PWR2005-50173

**THE PRACTICAL APPLICATION AND INNOVATION OF CLEANING TECHNOLOGY
FOR CONDENSERS**

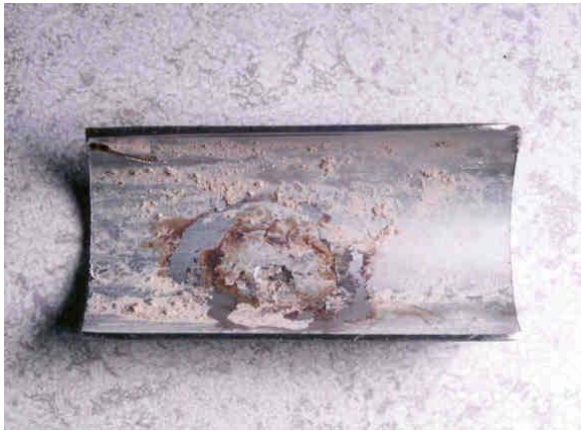
Figure 2
Pitting Under Scale in Stainless Steel Tube
(Photo Courtesy of Howell Image Sciences)

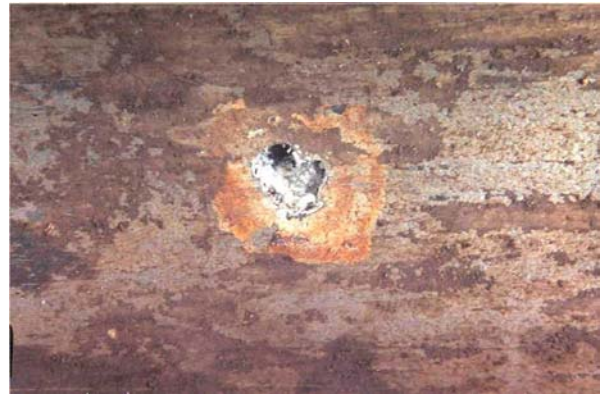
Figure 5
Pitting Due to Manganese Deposits
(Photo Courtesy of Howell Image Sciences)

As mentioned previously and as shown in Fig. 4, certain types of bacteria produce corrosive metabolic by-products (sulfate-reducing bacteria, SRBs); others (iron-oxidizing) may actually consume base metal. Corrosion by bacteria is usually not a serious problem except in cases where stagnant conditions exist (under deposits or scale, or off-line during unit outages). One exception is manganese pitting of stainless steel, which occurs on-line with a thin manganese oxide scale that is believed to be deposited by micro-organisms (Fig. 5).

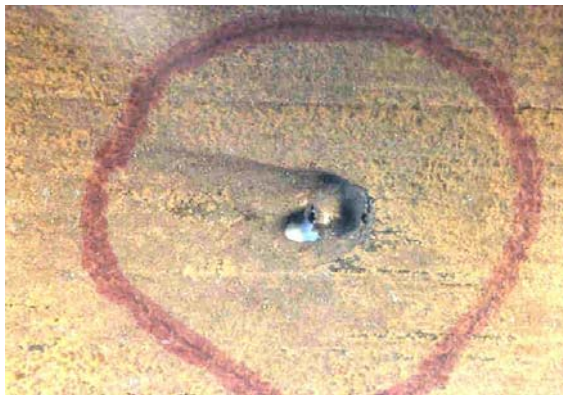
Figure 3
Erosion-corrosion Around Deposits
(Photo Courtesy of Howell Image Sciences)

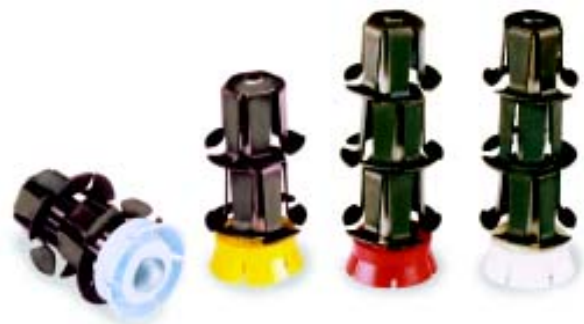
Figure 7
Hex Cleaner
Patent No. 0698423
(Photo Courtesy of Conco Systems, Inc.)

As a result of an innovative research program organized to resolve problems encountered in the field and to develop new products where existing equipment was found to be inadequate, new tube cleaners have been developed. For example, in order to provide the blades with more circumferential coverage of the tube surface, a new scraper design was introduced (Fig. 7). The increased contact surface provided by the greater number of blades was found to be more efficient in removing tenacious deposits such as those consisting of various forms of manganese.

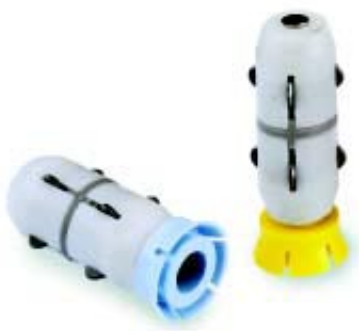
Figure 8
Cal Buster
Patent No. 5153963
(Photo Courtesy of Conco Systems, Inc.)

Another development involved a tool for removing hard calcite deposits, which were sometimes found to be difficult to remove in a timely manner, even by acid cleaning. This cleaner is shown in Fig. 8, and consists of a teflon body on which are mounted a number of rotary cutters. These are placed at different angles around the body, which is fitted with a plastic disk similar to those used to propel other cleaners through tubes. Used on condenser tubes that had accumulated a large quantity of very hard deposits, Stiemsma, et al [11] described how cleaners of this type removed 80 tons of calcite material from a large surface condenser. It has now become a standard tool whenever hard and brittle deposits are encountered. Hansen and Saxon [12] demonstrated the practical use of this tool for removing scale from stainless steel condenser tubes. Boroscopic photography shows the effectiveness of this cleaning tool in Fig. 9 and Fig. 10.

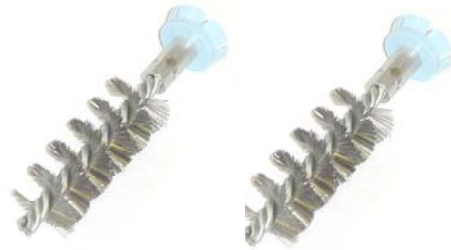
Figure 11
Stainless Steel Tube Cleaning Brush
Patent No. D450035
(Photo Courtesy of Conco Systems, Inc.)

Additional developments for the removal of manganese dioxide, iron oxide, and silica deposits include the stainless steel brush, which has over 1,000 contact points per brush (Fig. 11). Actual aluminum brass tube samples with iron and manganese deposits were examined in the "as found" and "as cleaned" condition (Fig. 12). After one pass of the stainless steel brush the cleanliness factor for the tube from waterbox A went from 83.3 percent to 91.5 percent, and from 73.6% to 94.1% in the tube from waterbox B.
